DUNWICH IRRIGATION AREA – COMPARING AIRBORNE LASER SCANNING WITH PHOTOGRAMMETRY

Report on Airborne Laser Scanning (ALS) trials conducted over the Dunwich Irrigation Area on North Stradbroke Island.

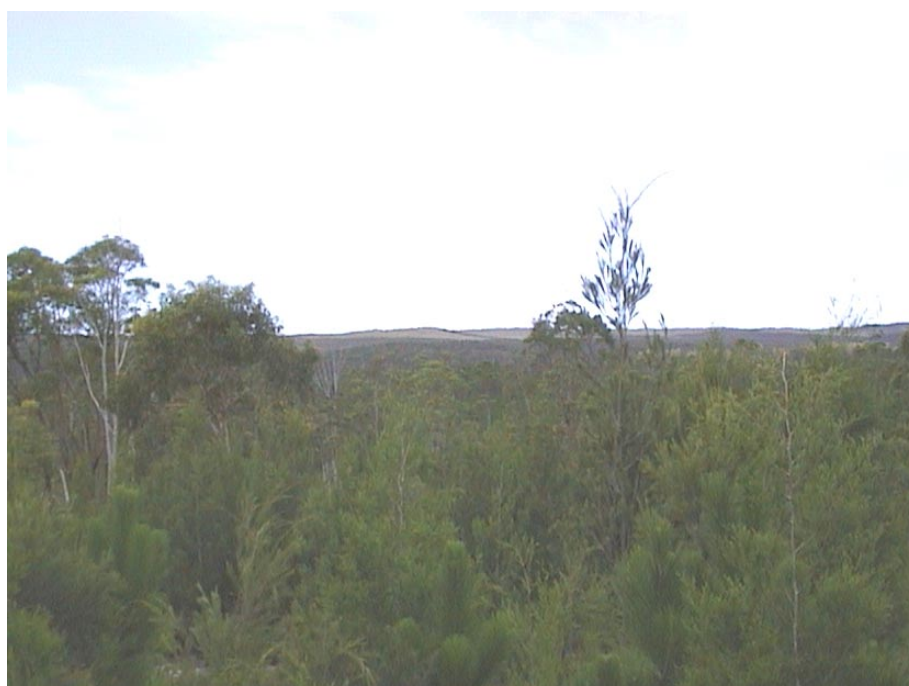
Figure 1
Project site from the Main Road

In July 2000, Redland Shire approached AAM GeoScan on the possibility of using Airborne Laser Scanning (ALS) to acquire a digital terrain model over the Dunwich Irrigation area. The site extends over 50 hectares, with vegetation cover varying from scattered established eucalypts through to predominantly dense plantation pine regrowth. Figure 1 shows the project area from the main road.

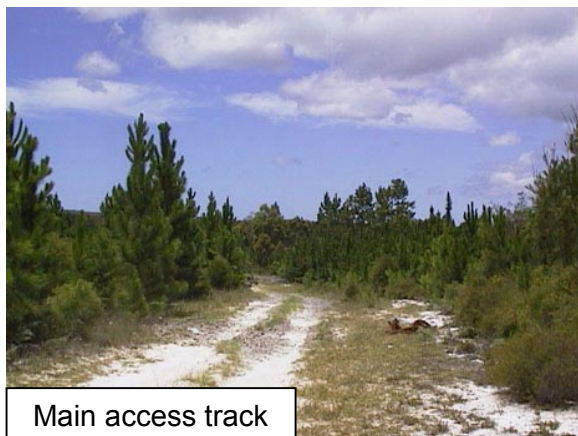
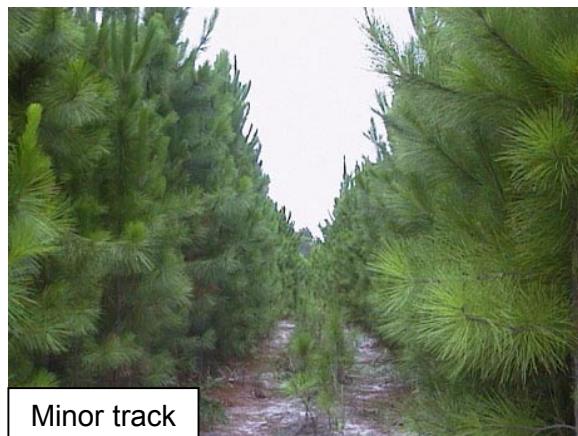
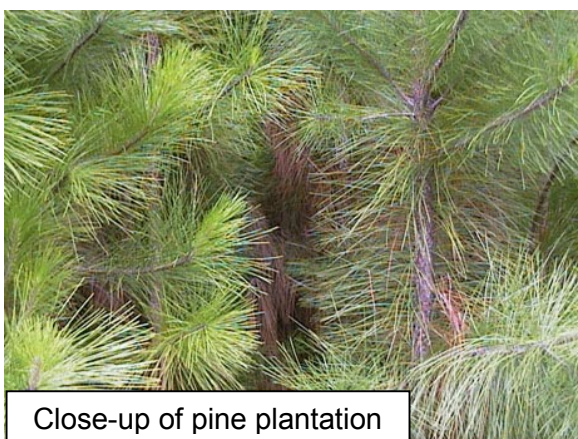
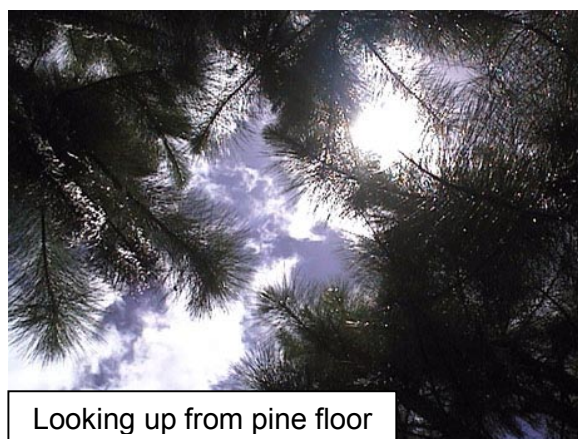
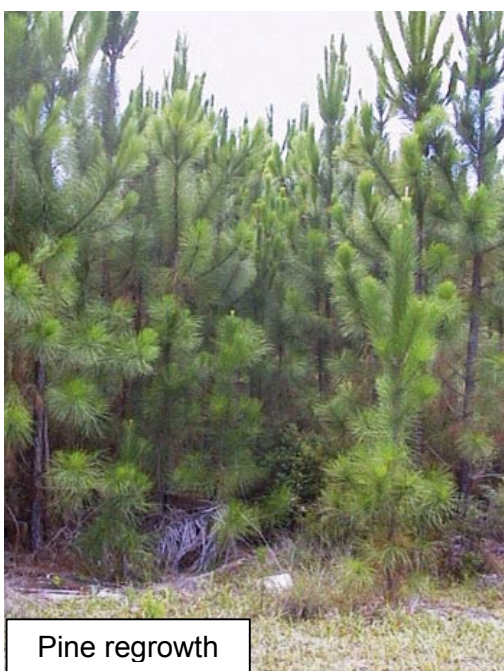
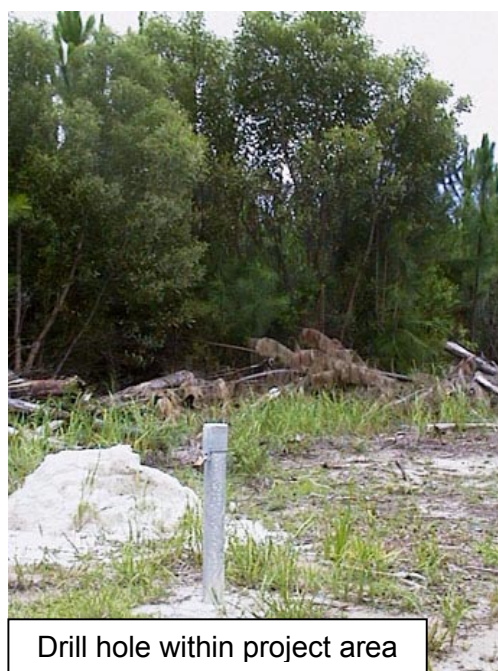
Figure 3 – Photo Gallery showing vegetation density

The ALS system emitted 10,000 laser points per second, which produced an average point separation of 1.4m. Due to the vegetation density, only 20.2% of the laser pulses penetrated through the vegetation to the ground. This resulted in an average *ground* point separation of 3.2m. Figure 3 provides an image gallery of the site, giving an indication of the vegetation density across the site.

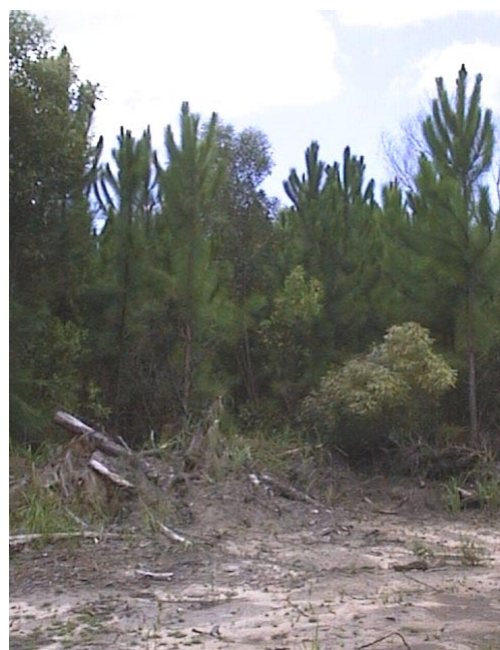
Figure 4
Piles of wood stacked after the fire can appear as changed terrain shapes

- measurement errors in the ALS (typically 0.15m rms);
- measurement errors in the photogrammetry (estimated to be 0.10m to 0.15m);
- interpolation errors in the ALS (with an average ALS ground point spacing of 3.2m, the height at each photogrammetric spot height was interpolated from the ALS data. This compares the ALS *model* with discrete photogrammetric *measurements*);
- forest litter on the floor, where the classification software was unable to identify a laser strike on fallen trees or dense undergrowth as “non-ground” strikes;
- changes in the terrain between the two surveys, most notably from clearing work done after the fire (see Figure 4).

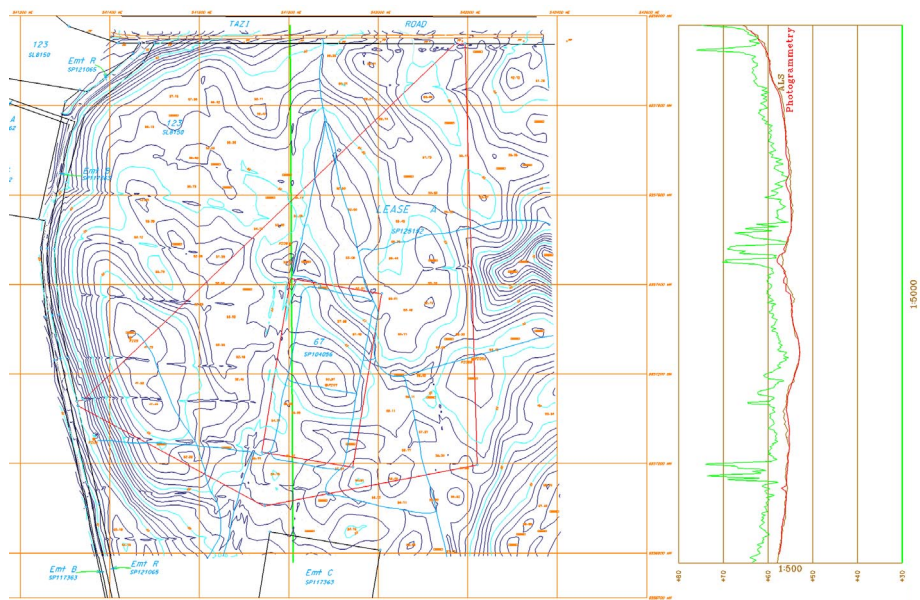
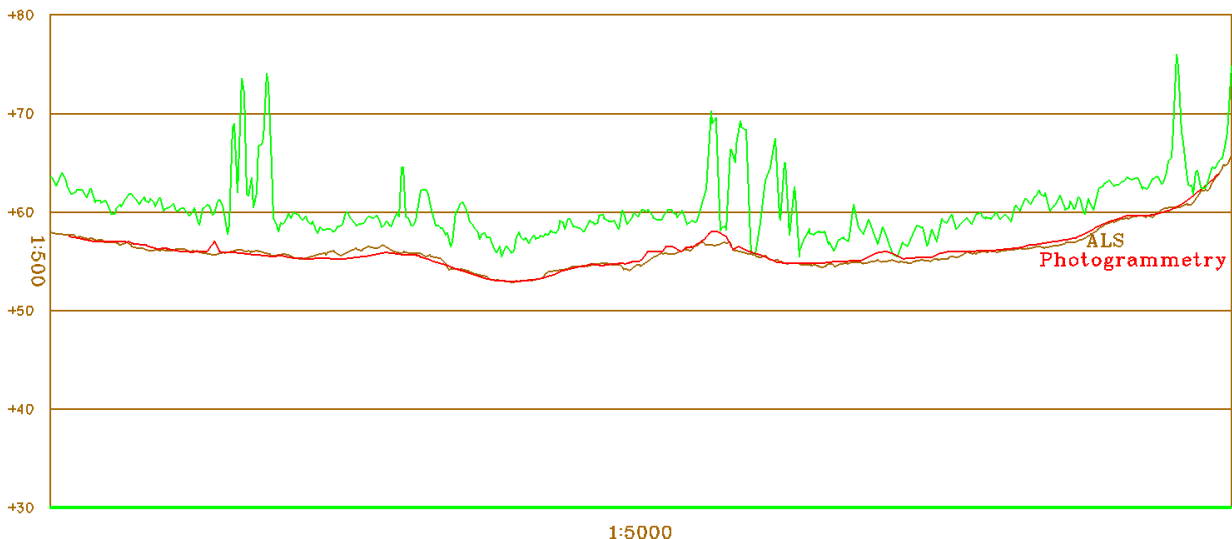
Figure 6
Profile
across the
project site.
Overall view
(right)
and enlarged
profile
(below)

Another method of comparing the two surveys is by constructing a profile. Figure 6 shows a profile line running the length of the project area. The red profile shows the photogrammetric surface derived from contours and DTM spot heights, the brown shows the ALS terrain and the green shows the ALS vegetation canopy.

There are three places where the ALS DTM sits significantly below the photogrammetric surface. In each case, this occurs at the crest of a small hillock and is due to the ALS classification software incorrectly deciding that the top of the hillock is a “non-ground” feature. The classification of laser strikes for this project adopted a generalised classification algorithm; these minor errors which lose the hillock tops could be improved by altering the classification algorithms.

The profile also shows how the ALS survey has detected small undulations in the terrain, whereas the photogrammetric survey has applied a generalisation to the terrain shape.

The vegetation profile shows the result of a classification routine aimed at defining the vegetation *canopy*. All non-ground laser strikes that were beneath the top of the canopy were suppressed from the vegetation model. The degree of generalisation of the canopy top can be tailored to suit the tree size and laser intensity.
